HISTORIC ATTICS: HOW TO RETROFIT WITH ENERGY & INTEGRITY IN MIND

A THESIS

BALL STATE UNIVERSITY

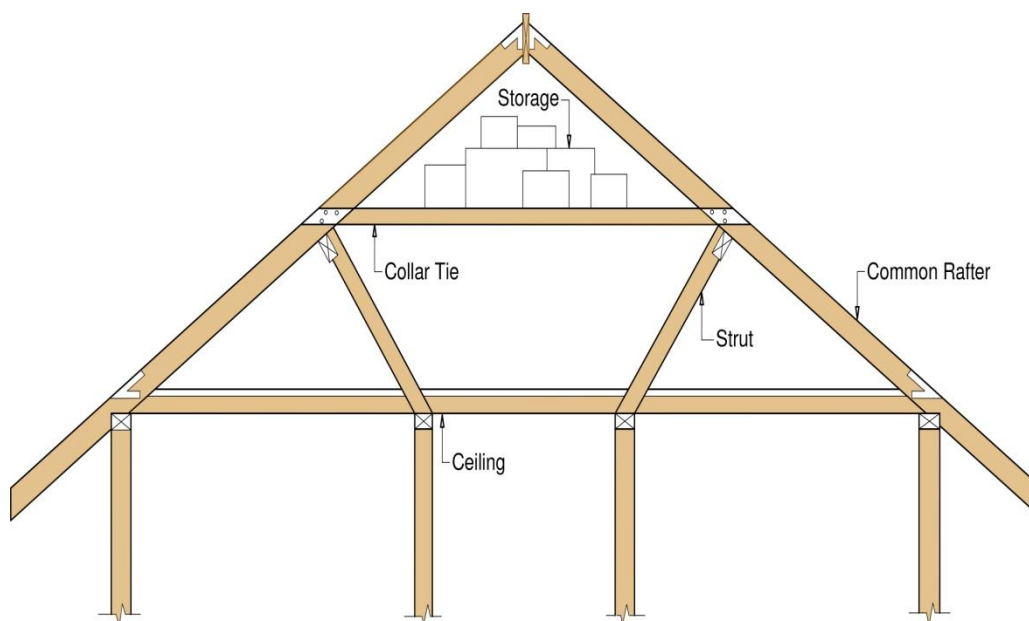
Figure 1.1 Storage Above Attic Tie Beam.⁷

story houses have a finished loft or attic space.² In some Shenandoah Valley houses, the concept of multi-level attic storage can be seen in the utilization of space above roof collars, or **tie beams**.³ Figure 1.1 shows what this type of storage might resemble. During the beginning of the 19th century, this type of house was abandoned for the I-house form. This change caused a shift in room function. Storage and farm-related activities that had been housed in the attic and cellar were later provided for in detached buildings.⁴

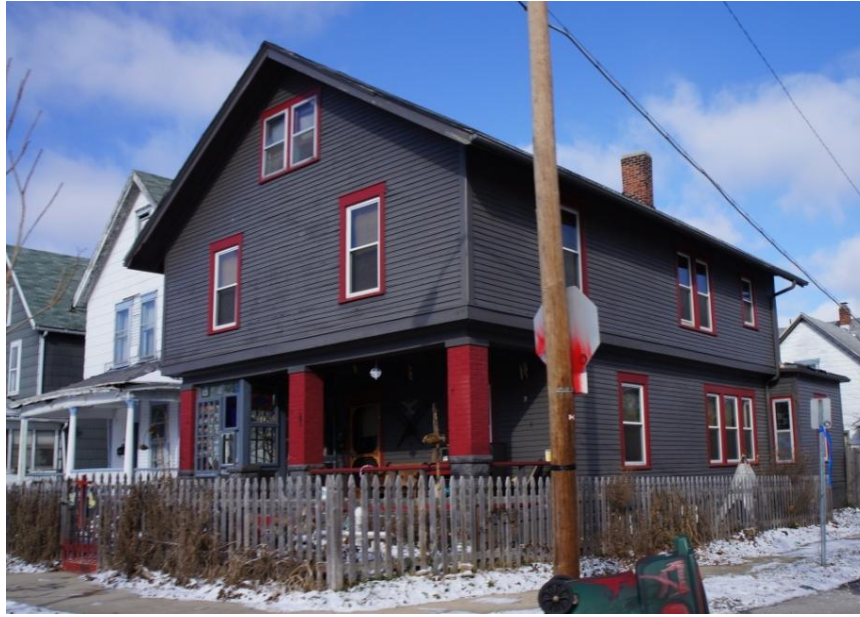
Figure 1.2 Jetty Characteristic of The Garrison House Style. South Gharkey Street, Muncie, IN.

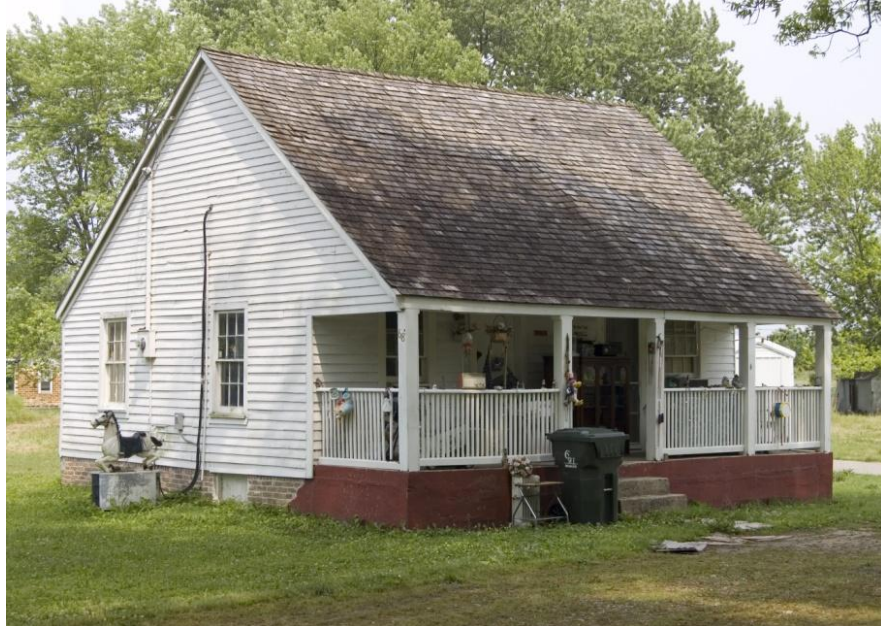
Figure 1.3 Grenier House Style. Ste. Genevieve, MO.¹²

This 18th century house type originated in the early French settlements of the United States within the **Mississippi Delta cultural hearth**. A cultural hearth is an original source area with distinctive settlement forms as well as other cultural attributes including building traditions.¹⁰ In the Mississippi Delta region, the cultural attributes had French and Cajun influences. Also known as the Acadian House or Creole House, the Grenier House (Figure 1.3) gets its name from the French designation of its oversized loft, or attic. Originally the attic space was used as sleeping quarters for the bachelor men of the family, but later functioned to store grains, pelts, and animal traps.¹¹

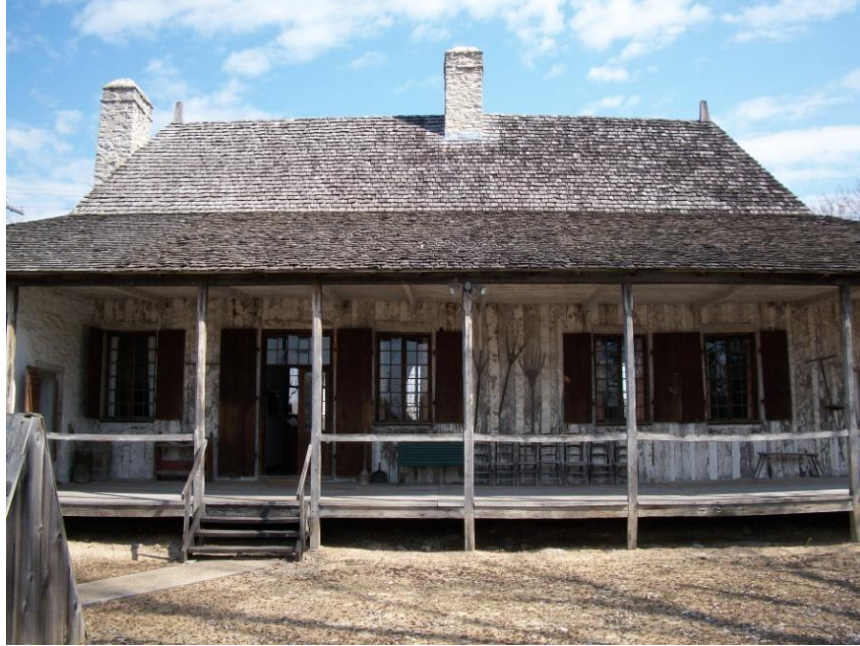
Figure 1.4 French Colonial Style House. Bolduc House in Ste. Genevieve, MO.¹⁴

French Colonial style houses (Figure 1.4) are distinguishable by their dual-pitched **hipped roofs** that in the original forms were thatch covered. In most cases the overhanging **eaves** of the roof encompassed a **gallery** that surrounded the house. Tall and narrow gabled dormers were sometimes used to provide attic lighting.¹³ Sometimes the roof is propped up off the structure's walls allowing for air movement. During the summer, a family could use this space to store and dry grain. Again, this style is not typical of Muncie's historic districts.

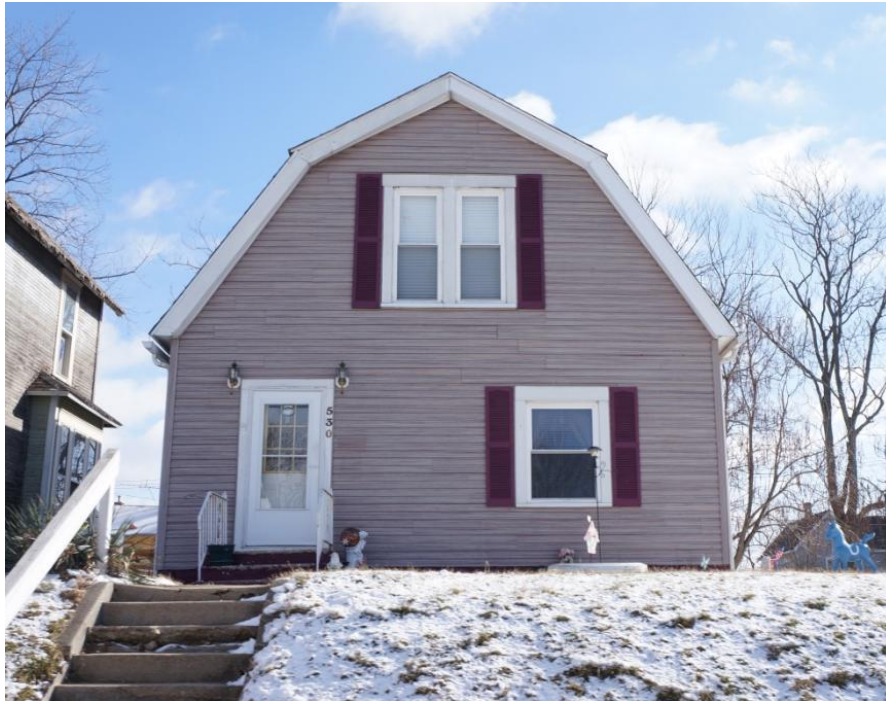
Figure 1.5 Dutch Colonial Revival Style House. South Mound Street, Muncie, IN.

story. Other features of this type that increased the headroom in the attic include separate dormer windows or a large shed dormer.¹⁷ This style can be seen occasionally in some of Muncie's historic districts. Figure 1.5 shows a more **vernacular** version of the style.

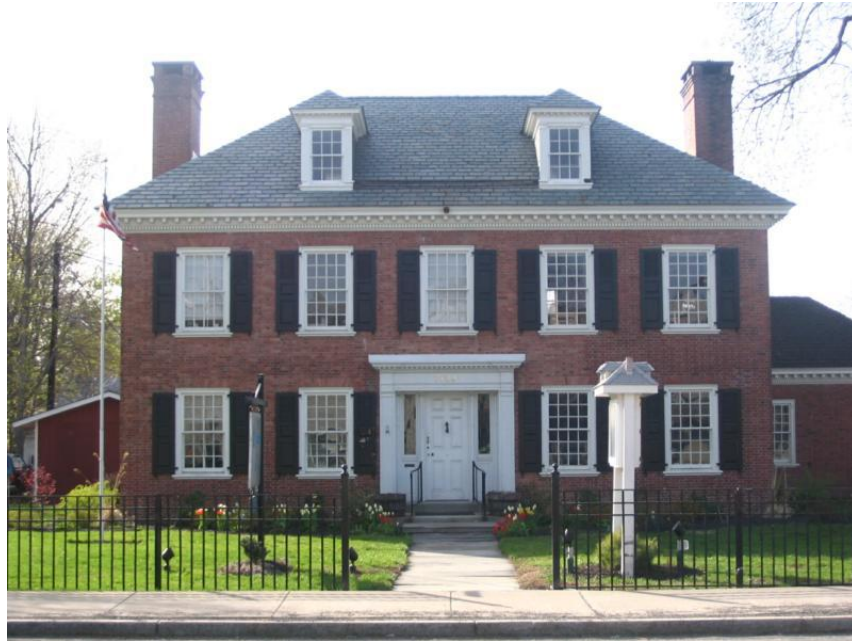
Figure 1.6 Georgian Style House.¹⁹

These simple, symmetrical houses may not seem as though they would contain large attic spaces, but the moderate to steeply pitched roofs usually contain dormers or gable-end windows that allow ample lighting and a decent amount of space (Figure 1.6). According to the McAlesters, about 25 percent of the surviving Georgian style houses are of the Gambrel Roof

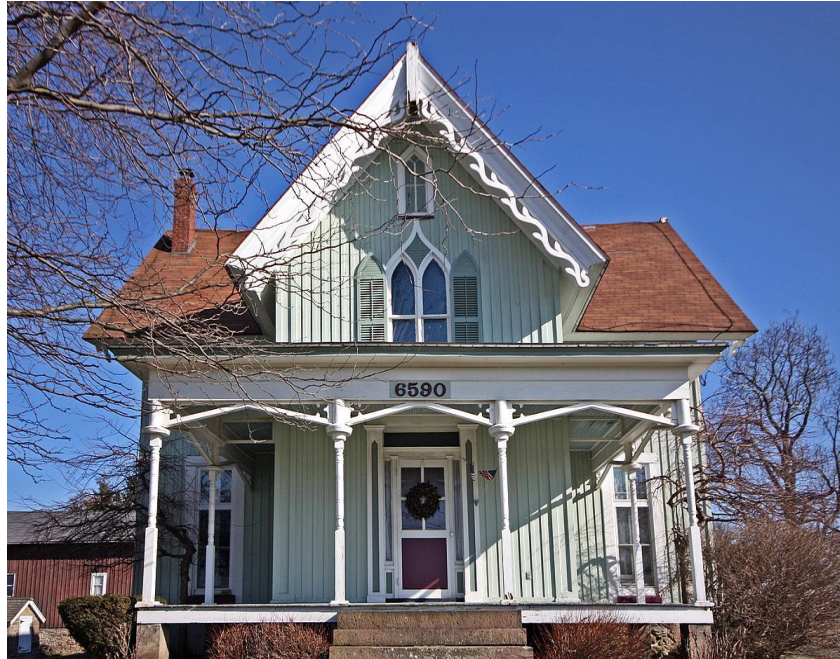
*Figure 1.7 Gothic Revival Style House.*²¹

Verticality is an important feature in Gothic Revival houses. This can be seen in the style's use of steeply pitched roofs and **wall dormers** (Figure 1.7).²⁰ Due to these characteristics, it would be plausible to assume that the attic spaces in these homes were used frequently. The wall dormers would not only allow light into the upper story, but would also

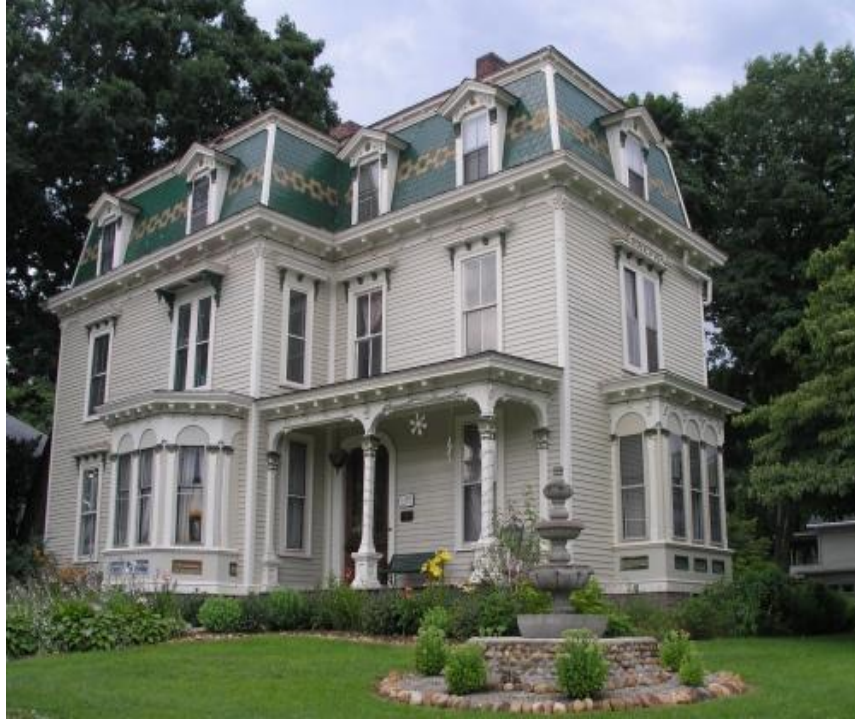
*Figure 1.8 French Second Empire Style House.*²³

This style (Figure 1.8) is characterized by its distinctive roof, known as a Mansard roof (named after French architect Francois Mansart).²² This type of roofline has two pitches and can either be convex or concave. The boxy roof line was considered particularly functional because it permitted a full upper story of usable attic space. Frequent dormer placement within the style also contributed to making the attic story usable by providing ample light. For these reasons, the style became rather popular.

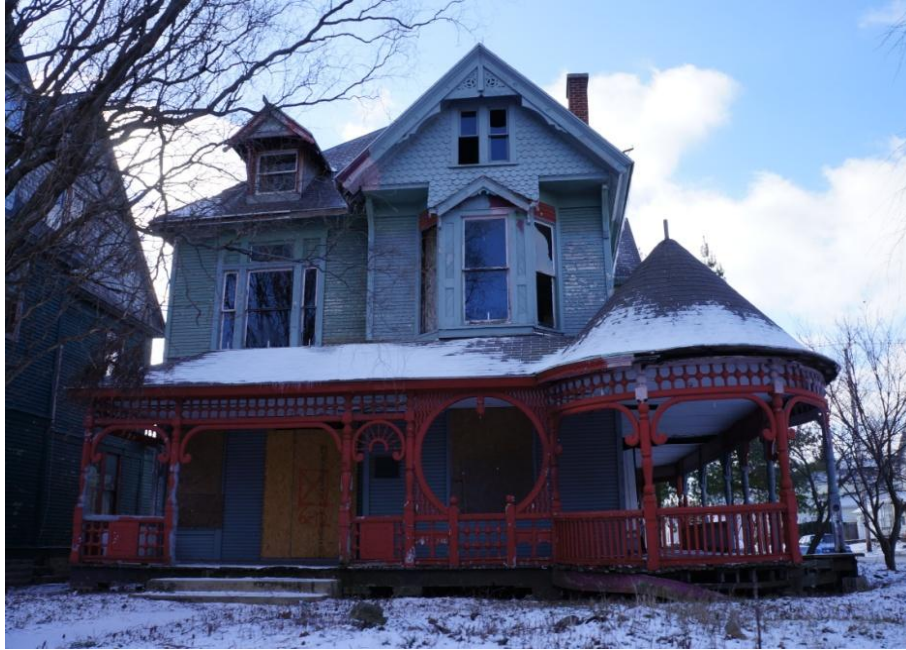
Figure 1.9 Queen Anne Style House. West Adams Street, Muncie, IN.

The irregularly-shaped Queen Anne house type of the Victorian Era has the most stylistic freedom (Figure 1.9). Typically, a house in this style is two full stories and is capped by a large third-story attic. The roof is steeply pitched and may either be gabled or hipped.²⁴ Characteristics of this style include dormers and several prominent and projecting gables, sometimes cantilevered out beyond the plane of the walls below. **Bay windows** are also common, which also provide for more usable space. This house type is common within Muncie's historic districts. Other Victorian Era houses like Stick, Richardsonian Romanesque, and Shingle have similar characteristics that make the attic space more functional.

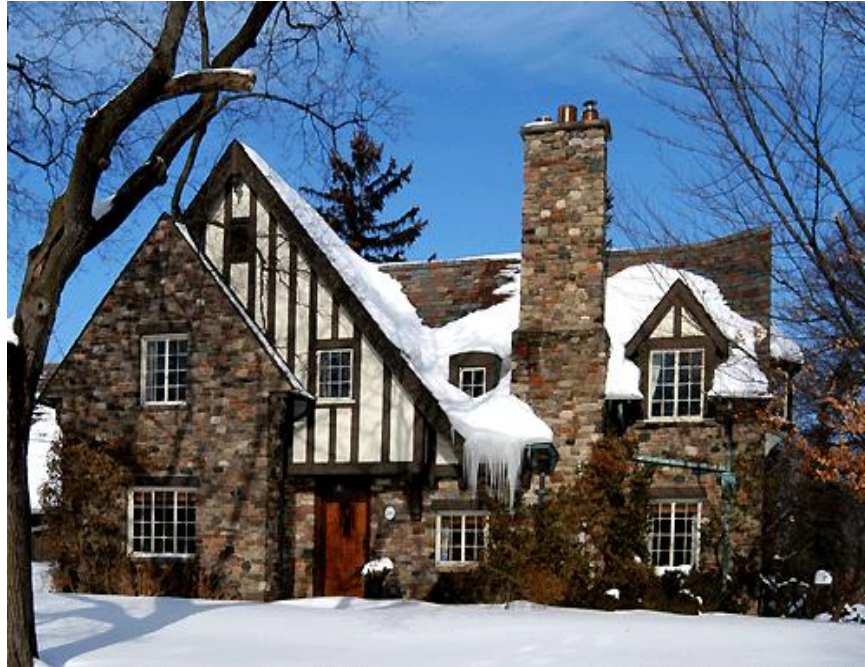
*Figure 1.10 Tudor Style House.*²⁶

This eclectic style is typically one story with a large steeply pitched roof, often with prominent **cross gables** (Figure 1.10). A dominant, front facing gable is common. Sometimes these gables are **parapeted** or have a slight overhang. Overlapping gables with eave lines of varying heights are common.²⁵ With these features, this style makes for a large attic space with ample headroom.

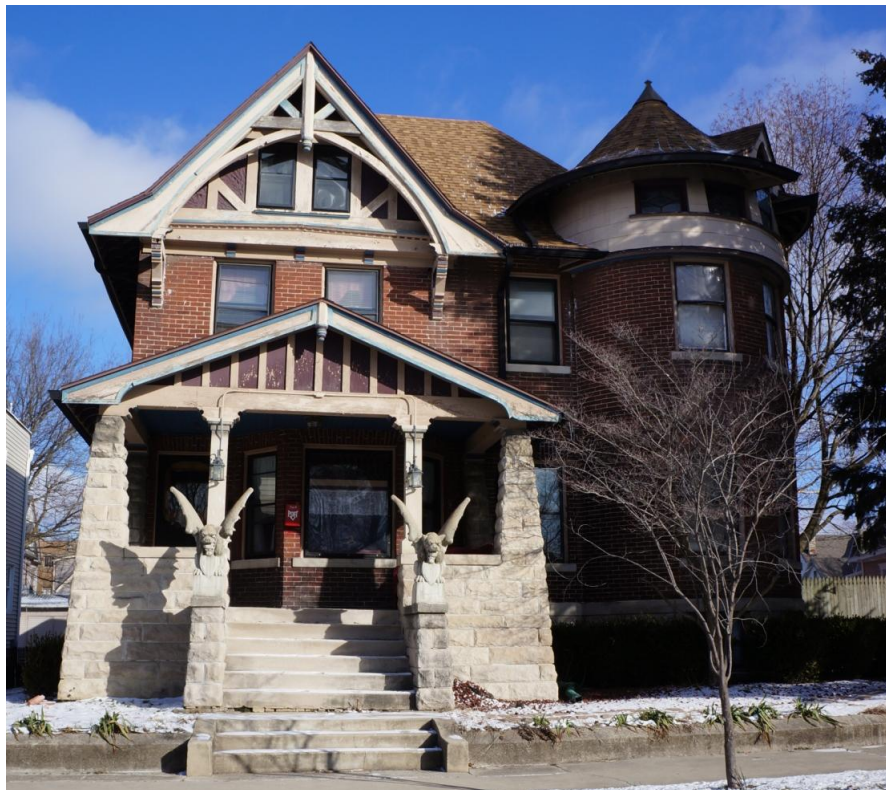
Figure 1.13 House With Potential For Usable Attic Space. West Charles Street, Muncie, IN.

In order to get a better feel for the types of houses that would have usable or non-usable attics within the neighborhoods, the following two examples show the differences that can be found within Muncie's Historic Districts. The house in Figure 1.13 for example, has a steeply pitched roof, various windows, and a dormer; it is possible for this Queen Anne style house to have a usable attic space. Figure 1.14 shows the opposite. There does not seem to be any type of headroom in this example due to its shallow pitched roof and it has no dormers or windows that would make someone suspect otherwise.

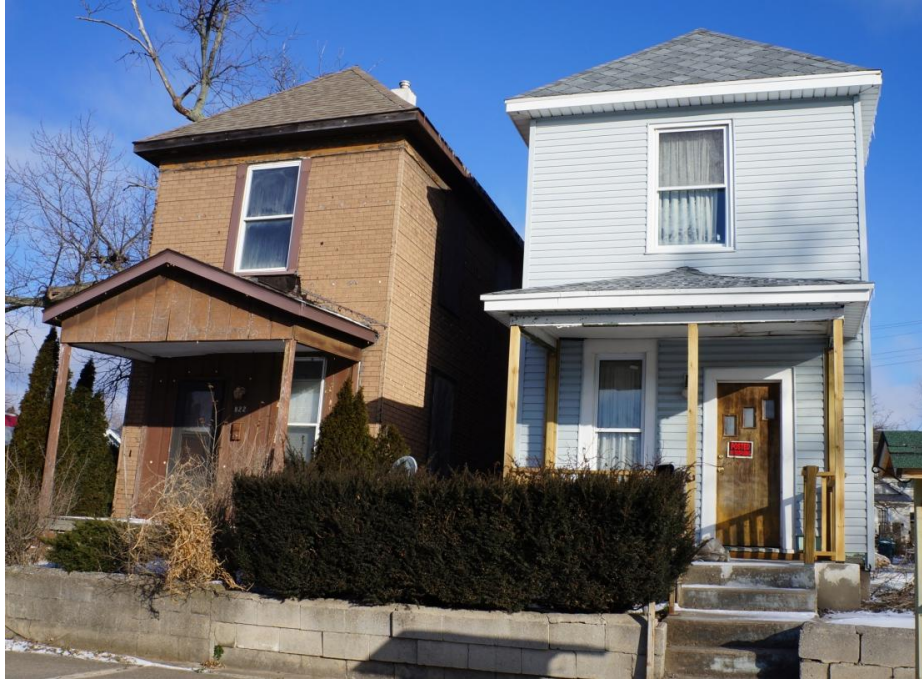
Figure 1.14 Houses Without Potential For Usable Attic Space. West First Street, Muncie, IN.

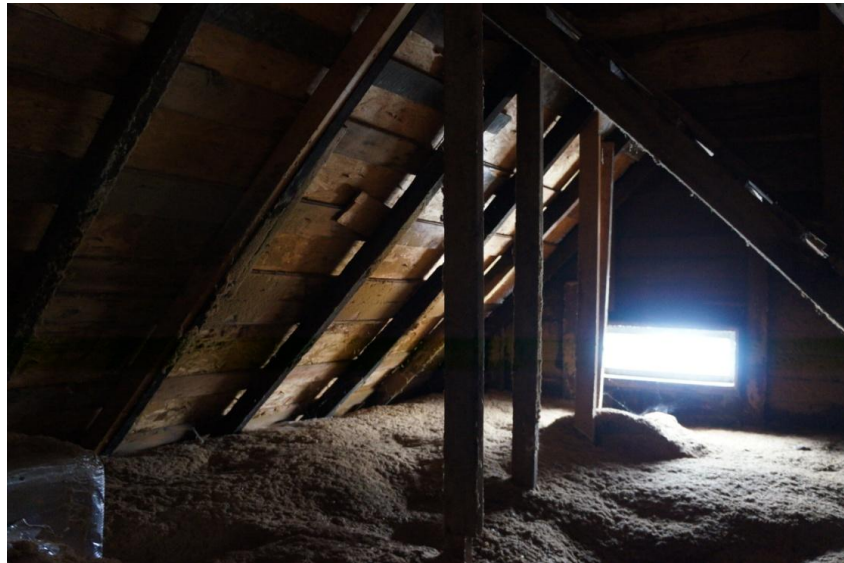
Figure 1.16 Queen Anne Residence Attic Space.

After touring a few homes in the Old West End Neighborhood and talking with the owners, some of them spoke of their desires to retrofit their attics into spaces they could utilize. One reason for this is the need for contemporary space to grow with the family. One family with a circa 1901 vernacular Queen Anne style house is currently not using the attic space at all. Attic windows give the indication that a more beneficial use would be plausible. This particular family had several ideas for what they would like to do with the space—including an extra bedroom, an artist studio, or a playroom for their child. Figures 1.15 and 1.16 show an exterior view of the house as well as a view of the interior attic space.

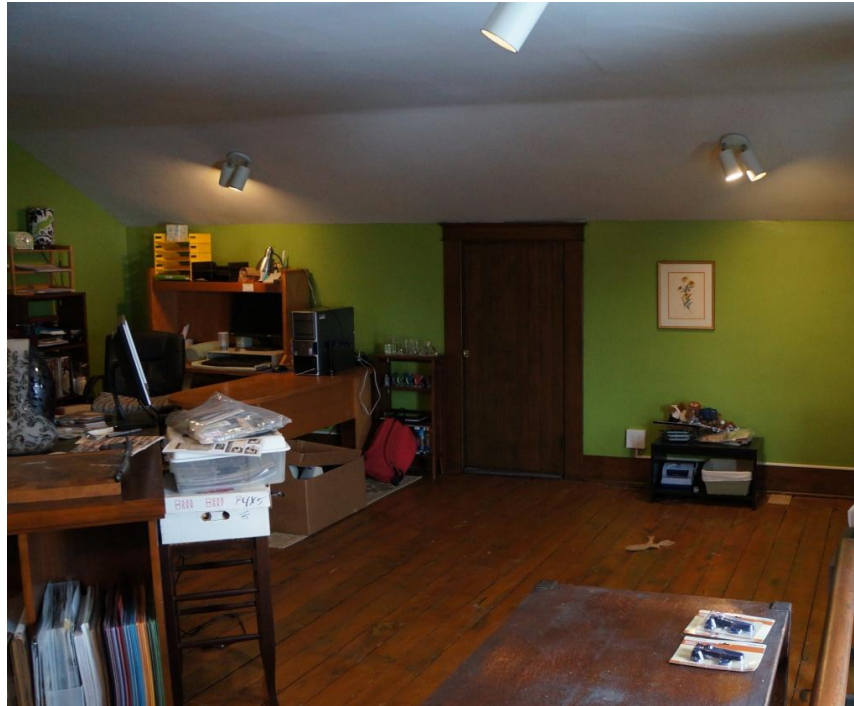
Figure 1.18 Dutch Colonial Residence Office Attic Space.

Another Old West End resident living in a 1900 Dutch Colonial house has been using the upper story as an office space, with the side attics being used for storage. In order to increase energy efficiency, the owners have stapled insulation to the walls of the attic. Figures 1.17-1.19 show an exterior view of the house and interior shots of the different attic spaces within the structure.

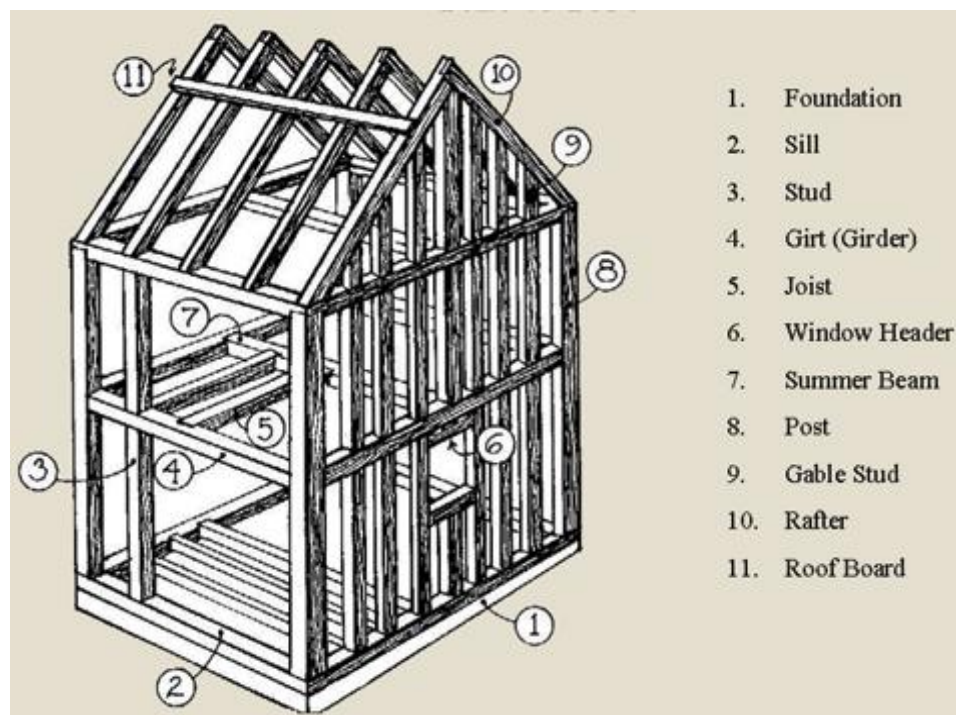
Figure 2.1 Diagram of the Braced Framing System.³

This framing system (Figure 2.1), a modification of post and beam framing, replicated hewn timbers by nailing lumber pieces together to form structural members as thick as timbers.¹ Because this method still used heavy corner posts and horizontal timbers, but employed thin **studs**, it essentially combined the heavy structural system of the post and beam method of timber framing, with lighter framing techniques. Thus began the creation of the stick framing method.²

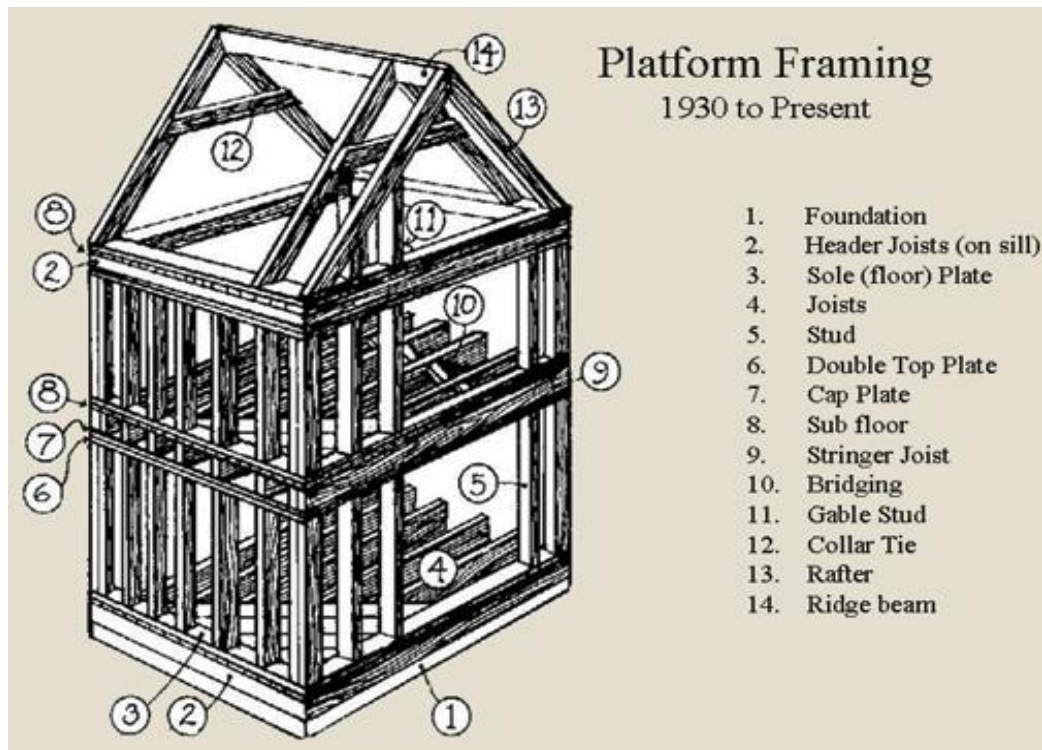
Figure 2.3 Diagram of the Platform Framing System.¹¹

catalogs and magazines.¹⁰ This type of construction is usually safer to build than balloon framing, because the numerous parts are not assembled many feet above the ground as in balloon framing construction. Sections can also be worked on simultaneously, allowing for better efficiency in aspects like construction time and labor hours.

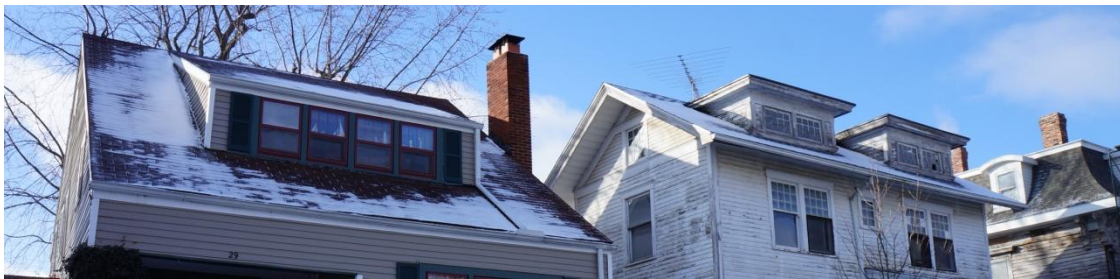
Figure 2.7 Examples of Dormers. West Orchard Street, Muncie, IN.

Some roof slopes are interrupted by dormers (Figure 2.7), usually having the same shape as the rest of the roof. These are meant to provide space, light, and ventilation to an attic and are therefore an integral part of the attic structure. They can be considered an architectural detail of the structure.

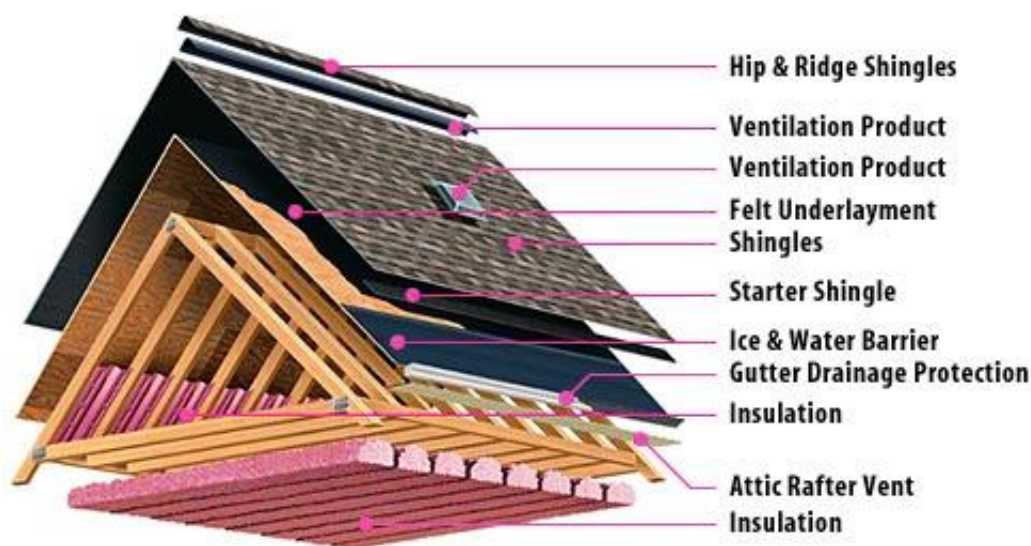
Figure 2.8 Roof Cladding.²⁰

Typically, above the rafters and roof decking, there will be a **felt underlayment** that rests underneath the roofing material. The roof decking, or sheathing, is applied to the roof rafters. The felt underlayment is attached to this layer to provide an extra (secondary) water barrier and protection for the attic and structure below. Roofing materials of historic homes vary from clay tile and slate to wooden shingles; however, there are also instances in which owners of historic homes have replaced these materials with modern **asphalt** based shingles.¹⁹ Figure 2.8 shows an example of typical modern roof cladding. Older homes usually have some form of roof vent or **soffit vent** to allow for ventilation of **unconditioned** attic spaces.

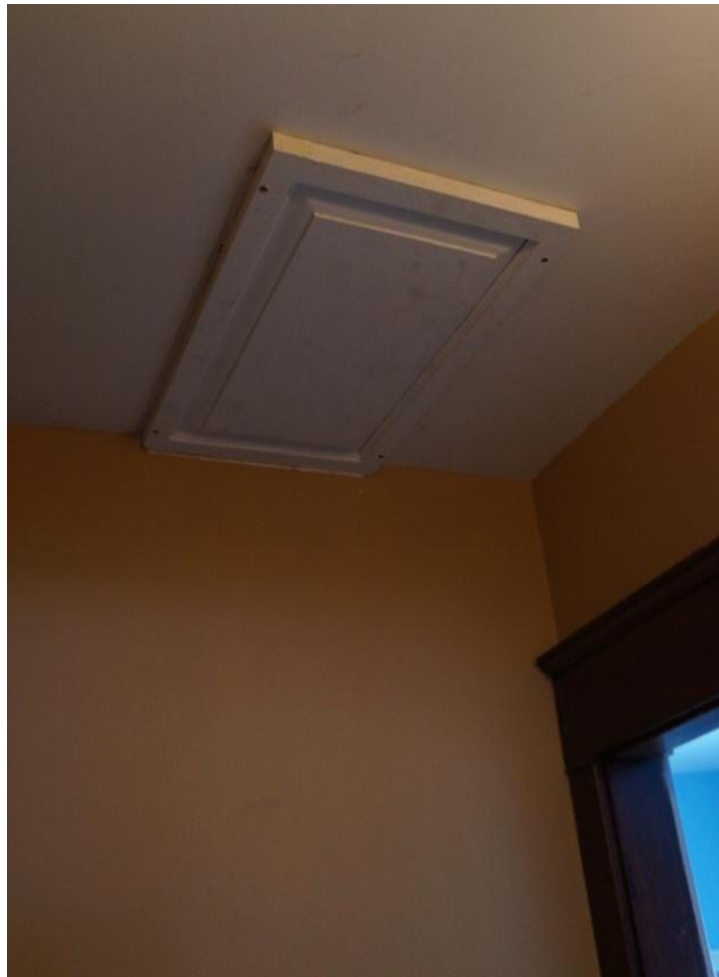
Figure 2.9 Attic Access Without Ladder. Queen Anne Residence, Muncie, IN.

The attic access, which can facilitate **stack effect** (discussed in Chapter 3) in a home and unconditioned attic, can also create problems for homeowners if they are trying to use the attic space. Some historic homes may just have a small rectangular access hole with no way of reaching the attic without a ladder (Figure 2.9), while others may have stairs leading to the space. Pull down ladder and hatch systems are the most common modern attic access types; however, not necessarily in historic homes. This system allows for wooden or metal stairs to be concealed within the attic hatch; these can be pulled down in order to climb up to the attic (Figure 2.10). A staircase is another common attic access type, in which a stair is built into the side of a room or hallway that

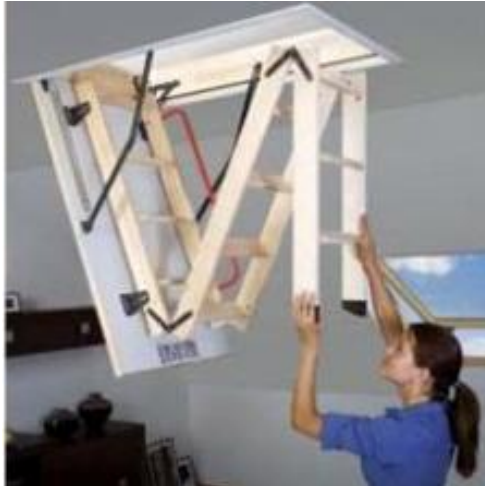
Figure 2.10 Attic Access Using Pull Down Ladder and Hatch Attic Access.²²

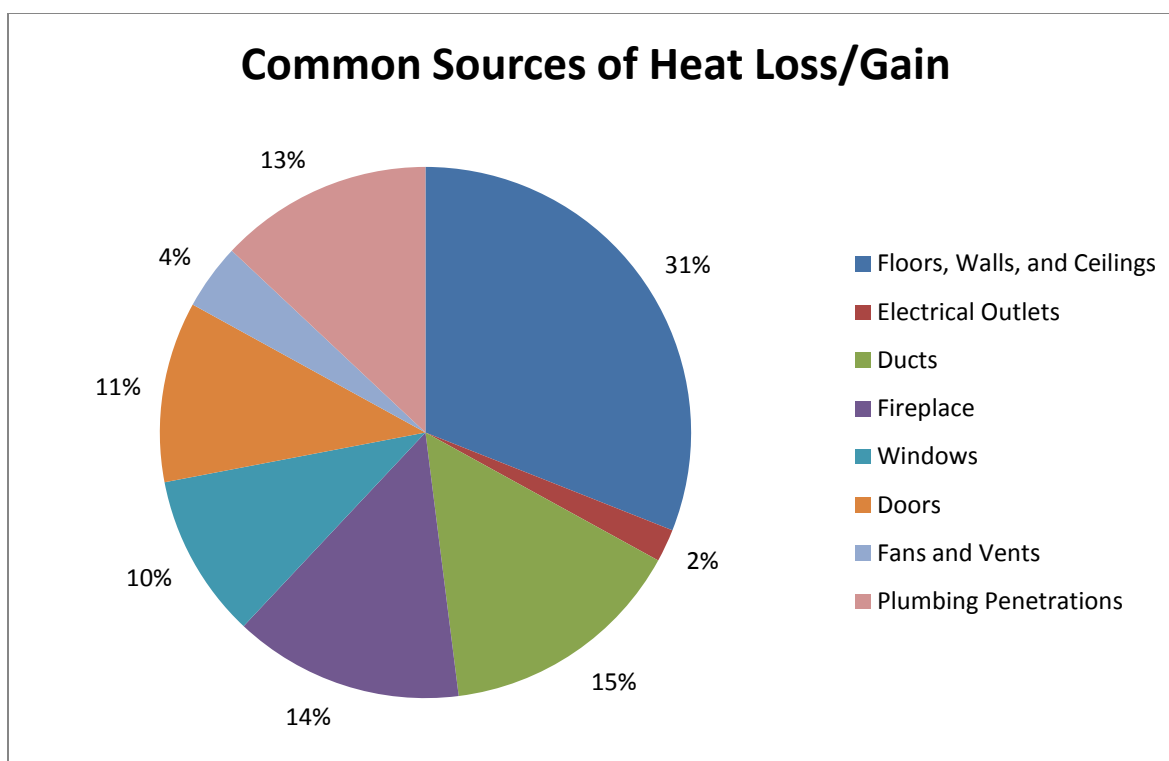
Figure 3.1 Common Sources of Heat Loss/Gain¹

A house, whether historic or modern, is always susceptible to heat gain/loss. This is due to a number of reasons: **convection**, **conduction**, **radiation**, and gaps along the **building's envelope** allowing for the transfer of heat. Typical sources of heat gain/loss in a home and how much heat flow they allow are shown in Figure 3.1.

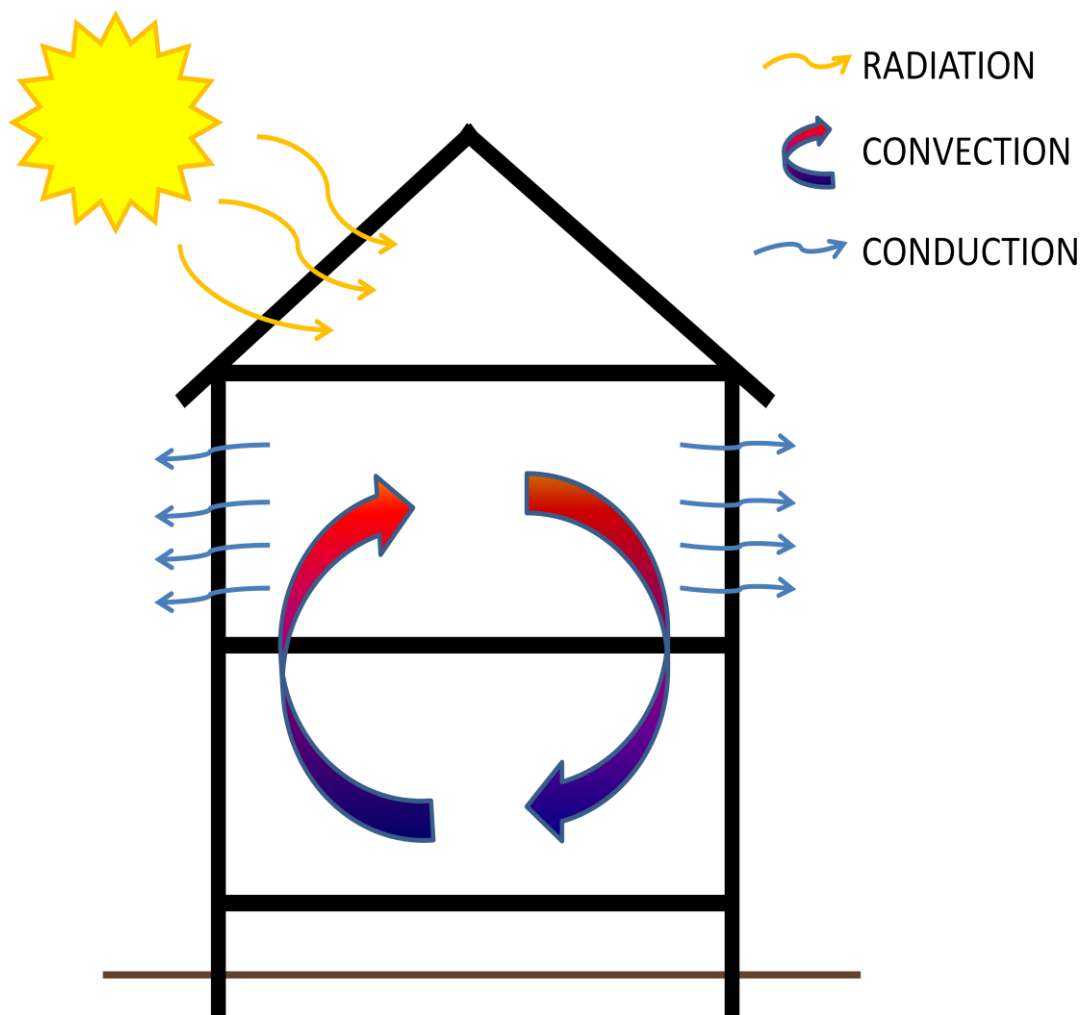
Figure 3.2 Primary Sensible Heat Transfer Elements

any given time. Conduction, convection, and radiation are sensible heat transfers which impact temperature. Evaporation relates to latent heat which impacts moisture content.³ Convection and conduction, and to a lesser extent radiation, can be impeded by insulation while radiant barriers and **vapor barriers** help to reduce radiation and evaporation. However, without a tightly sealed **air barrier**, insulation can be bypassed allowing for heat gain and loss via infiltration. Figure 3.2 shows how sensible heat can move across a building's envelope.

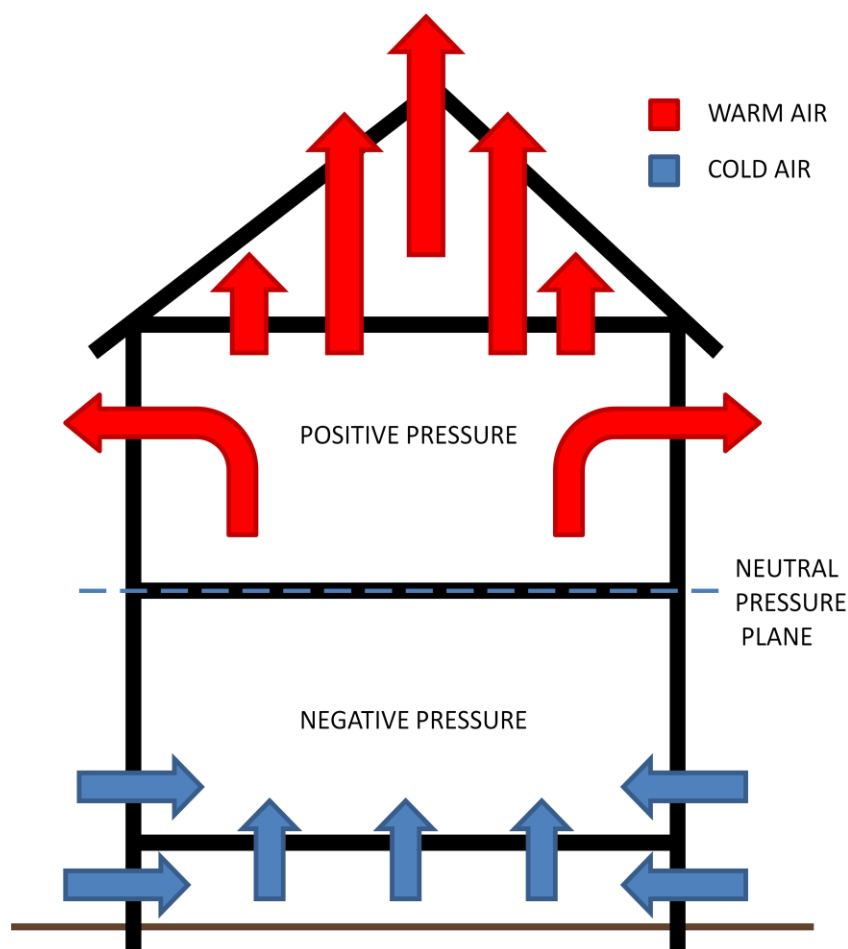
Figure 3.3 Stack Effect Diagram

The difference in air densities between warm air inside a home and cold air on the outside creates an air pressure difference that in turn causes air to move. This is known as stack effect. The result of this driving force is that cold air is drawn into the house at the lower levels, such as a basement or **crawlspace**, where it is warmed, and then escapes through holes near the top of the house, most likely in the attic. Stack effect gets its name from the fact that the air movement resembles the flow in a chimney or smoke stack with air traveling in at the bottom and exiting or exhausting out the top. The highest pressure differences resulting from stack effect occur at the highest and lowest parts of a building. During winter at the top of the house, the pressures are positive with reference to the outside, while the bottom of the house has negative pressure with reference to the outside.⁸ The middle portion of the building, where the pressure difference between the inside and outside is zero is called the neutral pressure plane. Building enclosure holes or gaps near the neutral plane are not as significant and do not need as much attention as those in the negative or positive pressure plane.⁹ Two factors that are directly associated with these pressure differences are the temperature difference between the inside and outside of a house and the height of the house. The taller the house and the greater the temperature difference, the greater the stack effect in the house. It is also important to note that these pressures are continuous, and are, therefore, constantly occurring in a home.¹⁰

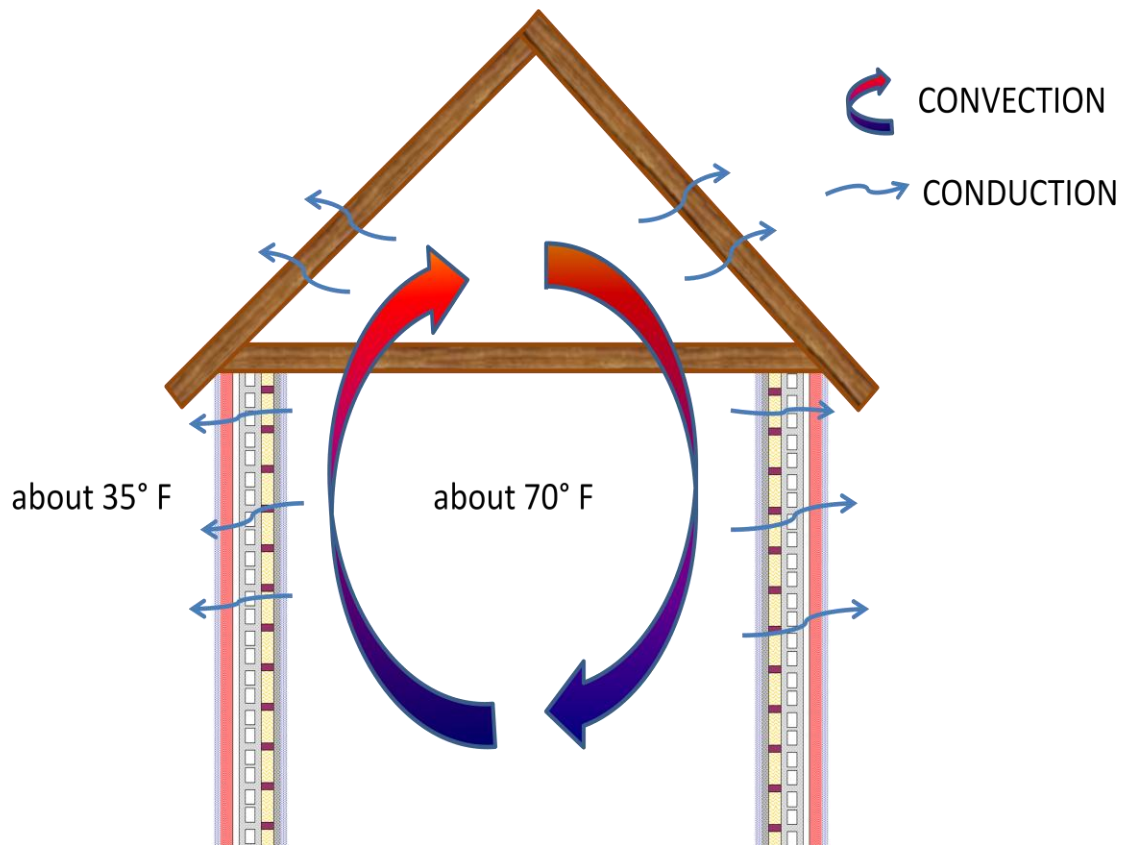
Figure 3.4 Heat Flow through Walls and Roof

Air leaks through cracks and holes are not the only way in which heat flow can occur across a house. Heat is also gained or lost through the roofs and walls of a home caused by temperature differences that drive convection and conduction, and by radiation flows. Due to a home's natural convection, heat will rise into the attic. Heat will then travel through a wall or roof from a higher temperature to a lower temperature. For instance, if the temperature in a house is 70 degrees and the temperature outside is 30 degrees, the heat within the home will flow through the wall and/or roof assemblies to the lower temperature (Figure 3.4). Wall and/or roof assemblies are made of several materials that each have a different resistance to heat flow. The types of materials used within an assembly will determine the rate of heat flow in and out of a home through these assemblies.

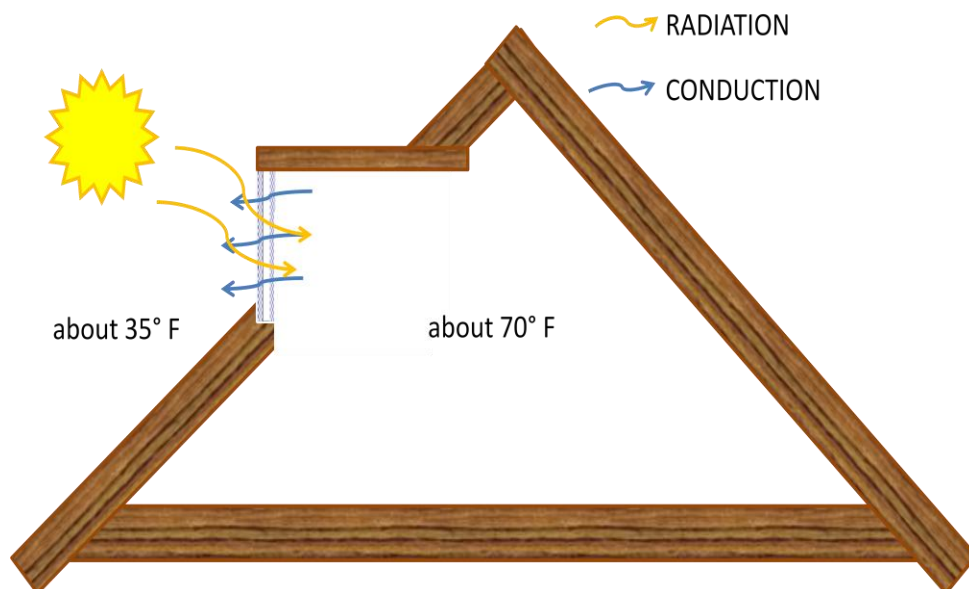
Figure 3.5 Heat Flow through Windows

materials of the walls.¹² Figure 3.5 depicts how conduction, convection and radiation occur through the transparent material of a window.

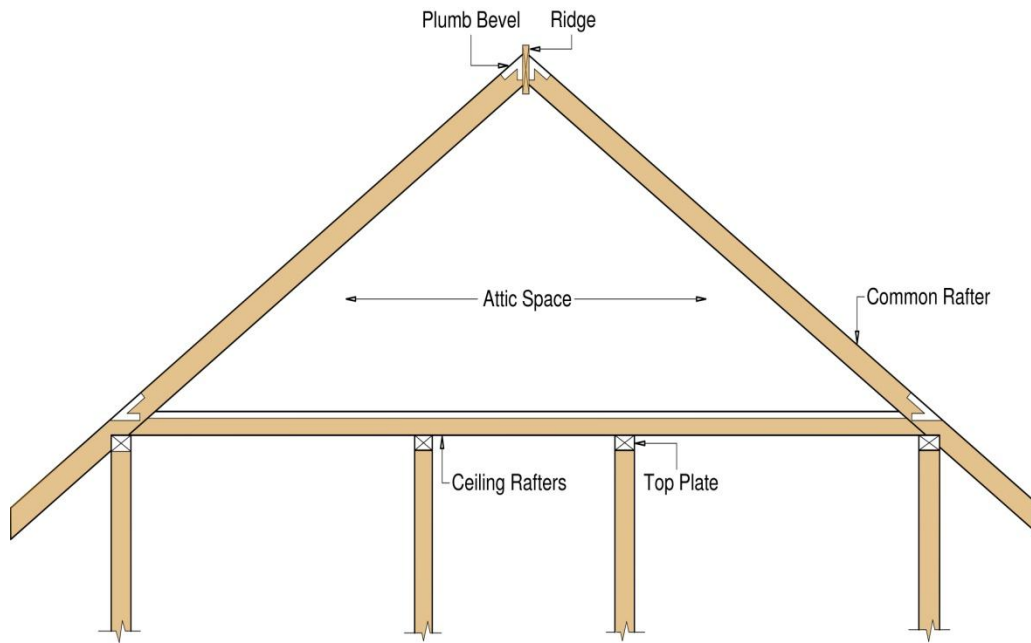
Figure 5.1 Simplified Attic Space⁵

Attics of historic houses vary in size and structure, but have similar characteristics in terms of construction (Figure 5.1). Some attics may have a small access door that can only be reached by ladder, while others may have stairs that lead up to the space. In some instances, there may not be covering over the floor joists, but in others wooden planks are assembled to create a walk-able floor. Unless altered, most if not all of these spaces are unconditioned. In an unconditioned attic, it is common to see loose-blown or loose-fill insulation installed directly into the attic space between the floor joists.

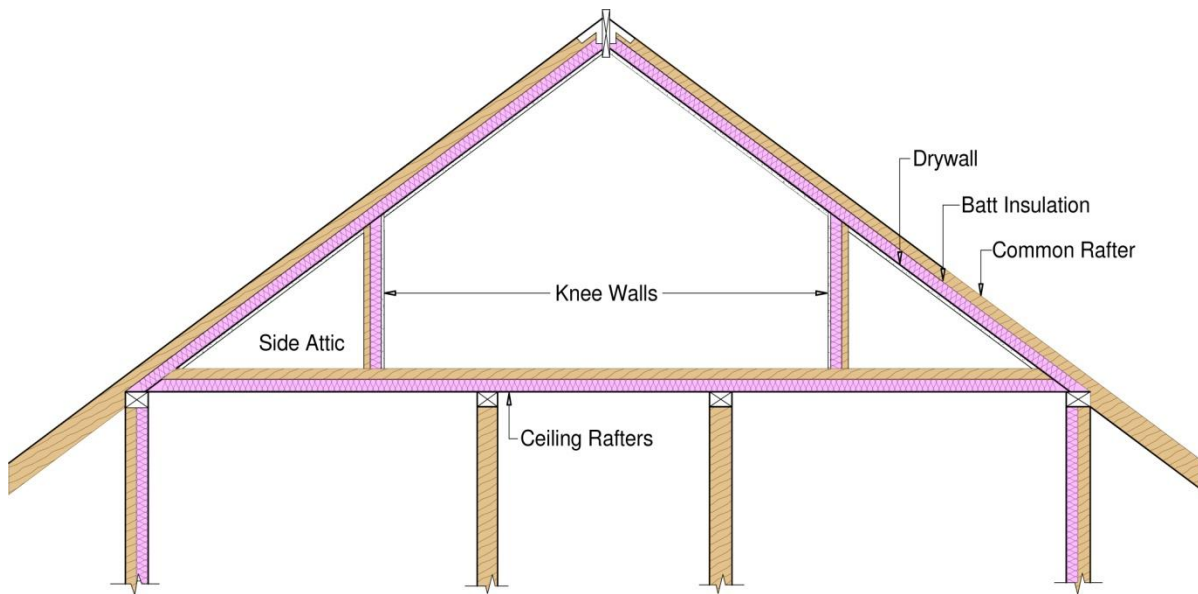
Figure 5.2 Insulation of Attic Space with Knee Wall Construction⁷

The first alternative, a common method in converting attic space to be better utilized, is by using drywall to section off the shorter spaces of an attic that are harder to use (Figure 5.2). The space in the attic where the floor meets the roof rafters is not easily usable because of the lack of head room. Therefore, when an attic is turned into a conditioned space, people install short walls, referred to as **knee walls**, that close off the area where the ceiling and floor meet, creating a side attic. The framework for the knee walls is built first, typically built about four or five feet tall.⁶ The book, *New Living Spaces*, gives a more in-depth look at the construction of knee walls. After the framework for the knee walls is installed, **fiberglass batts**, or even rigid foam insulation, are put in place to insulate the space. The batts are laid between the wall

Drywall should then be placed on the knee walls, up the slant of the roof and ceiling to finish the space.

The benefits of this approach are few. In regards to the Secretary of the Interior's Standards for Rehabilitation (discussed in Chapter 4), this approach may be appropriate due to the fact that the renovation could be easily removed at a later date if necessary. The fiberglass batt insulation materials are not only removable, but should also not damage the historic fabric into which they are placed. Covering up the roof rafters, depending on how the attic is constructed, may slightly take away from the integrity of the space by both changing the feel of the space and by covering up the construction and "bones" of the attic. Aside from that, this approach would have minimal adverse effects on the historic integrity of the home. The
